# Intel<sup>®</sup> Pentium<sup>®</sup> 4 Processor

## Specification Update

*May 2003*

Document Number: 249199-036

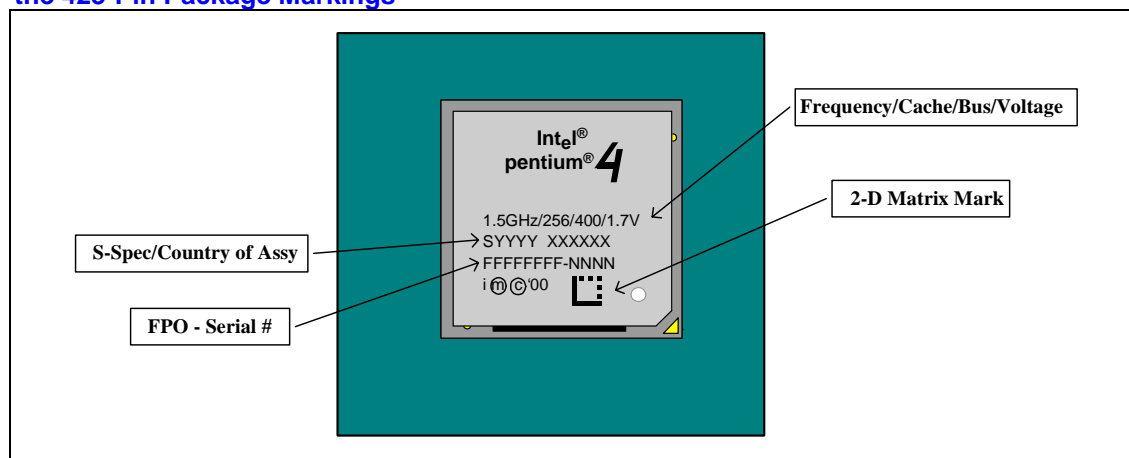
Figure 1. Intel® Pentium® 4 Processor in the 423-Pin Package and Boxed Pentium 4 Processor in the 423-Pin Package Markings

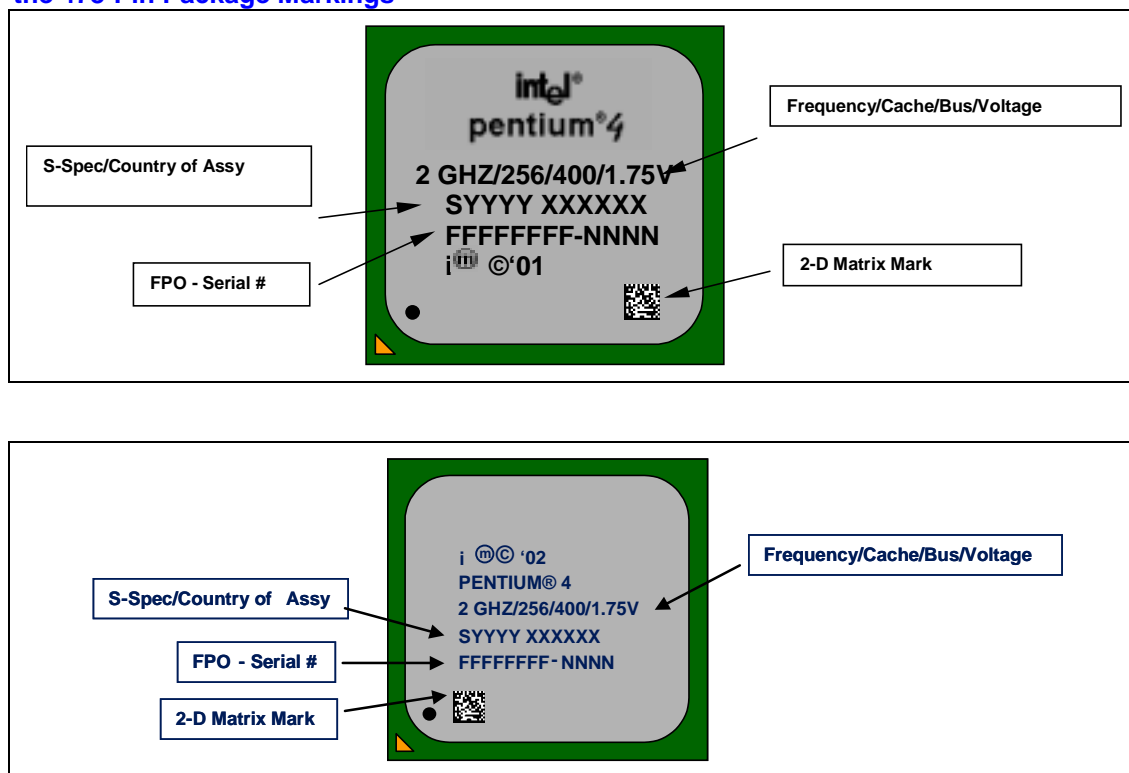
**Figure 2. Intel® Pentium® 4 Processor in the 478-Pin Package and Boxed Pentium 4 Processor in the 478-Pin Package Markings**

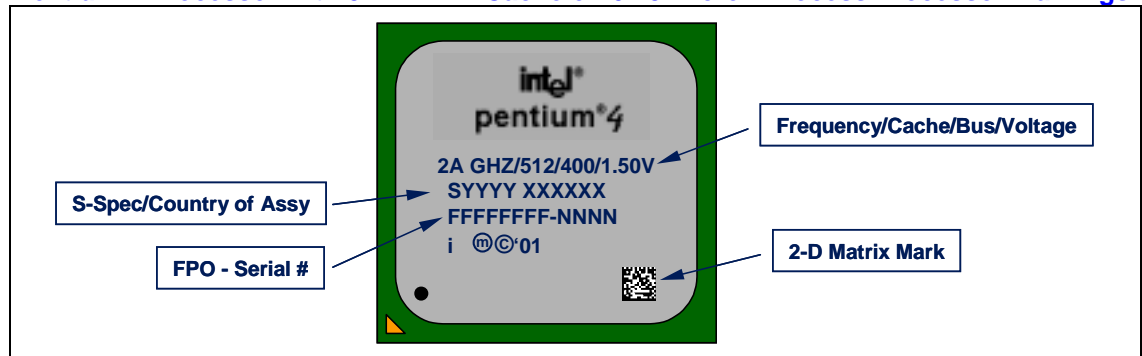
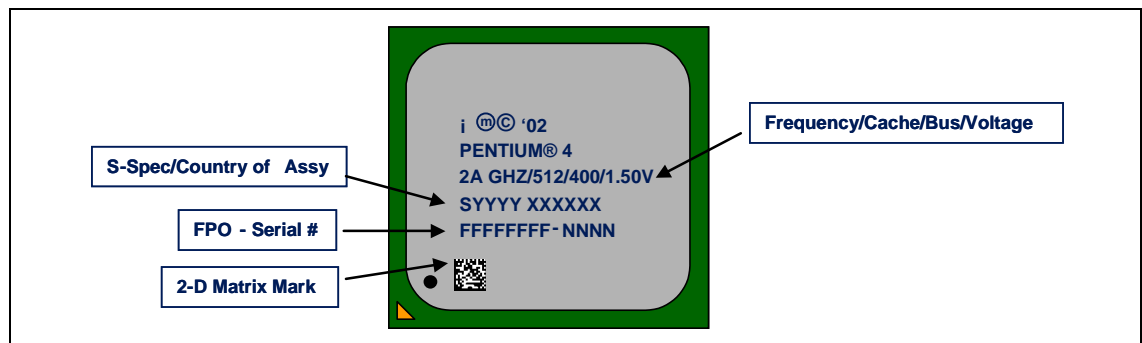
**Figure 3. Intel® Pentium® 4 Processor with 512-KB L2 Cache on 0.13 Micron Process and Boxed Pentium 4 Processor with 512-KB L2 Cache on 0.13 Micron Process Processor Markings**

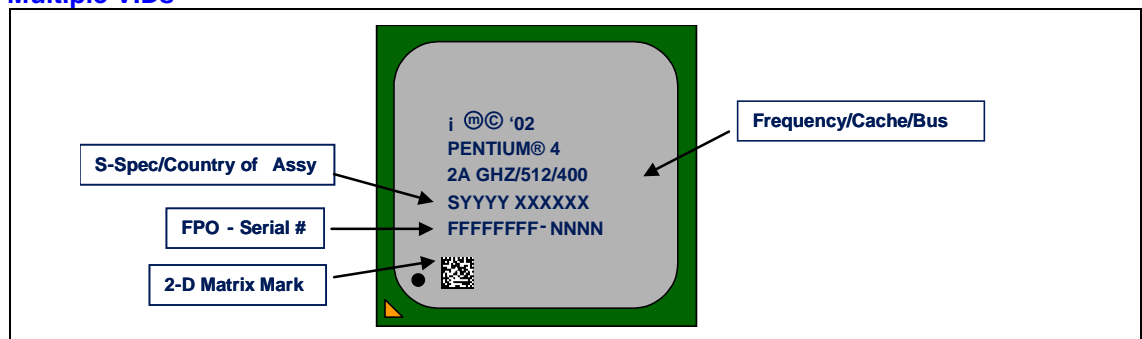
**Figure 4. Multiple VIDs**
